MARYLAND HISTORICAL TRUST

INVENTORY FORM FOR STATE HISTORIC SITES SURVEY

Thomas Patten House

Bruchey House

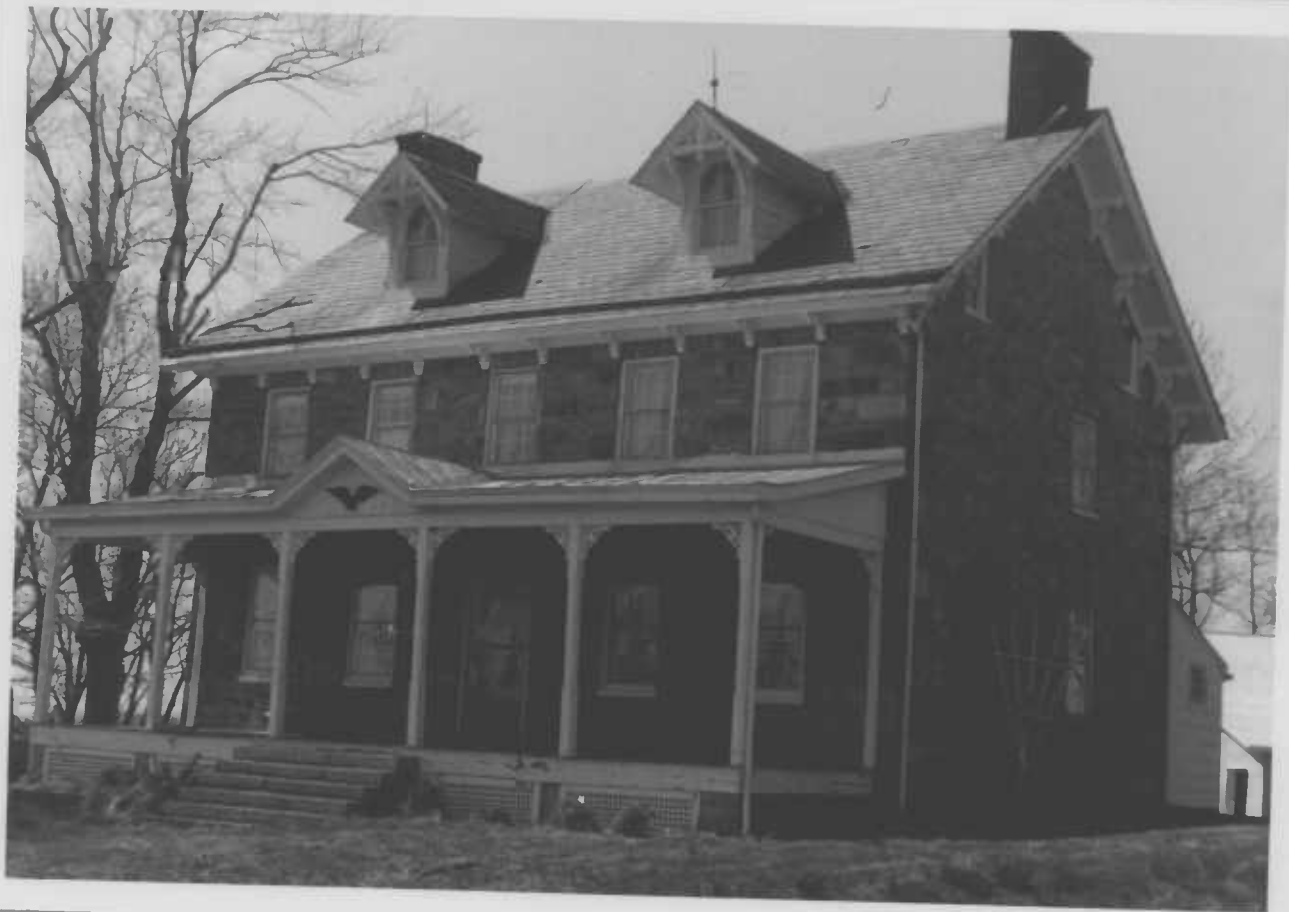
East Elevation

The main elevation consists of five evenly spaced bays with a central entrance. A six panel front door has a single light transom and four panel reveals. The surround consists of a half round, and frames 9/6 sash on the first floor and 6/6 second floor sash. Granite jack arches support each opening. A shed roof front porch covers the entire first floor and appears to have been added about the same time as the roof alterations. The porch roof has a central pediment covered with fishscale shingles. The porch roof is supported by chamfered posts with decorative sawn bracket ornaments.

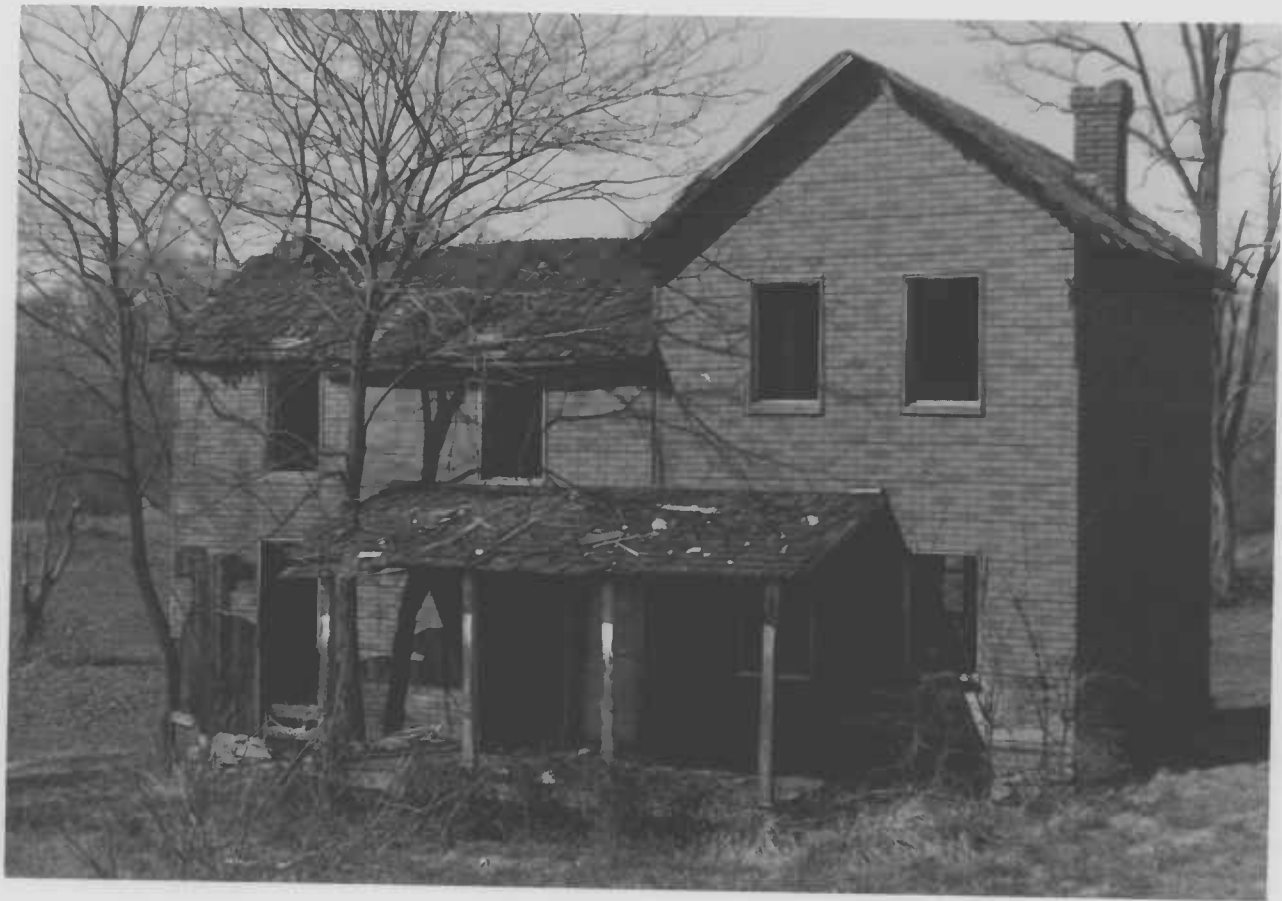
TENANT HOUSE - WEST ELEV.

A two story ell shaped frame tenant house from the third quarter of the 19th century stands north of the main ~~block~~ house. The structure seems to have been built in two stages. One section covered with weatherboard siding and the other sheathed with vertical board sheathing.

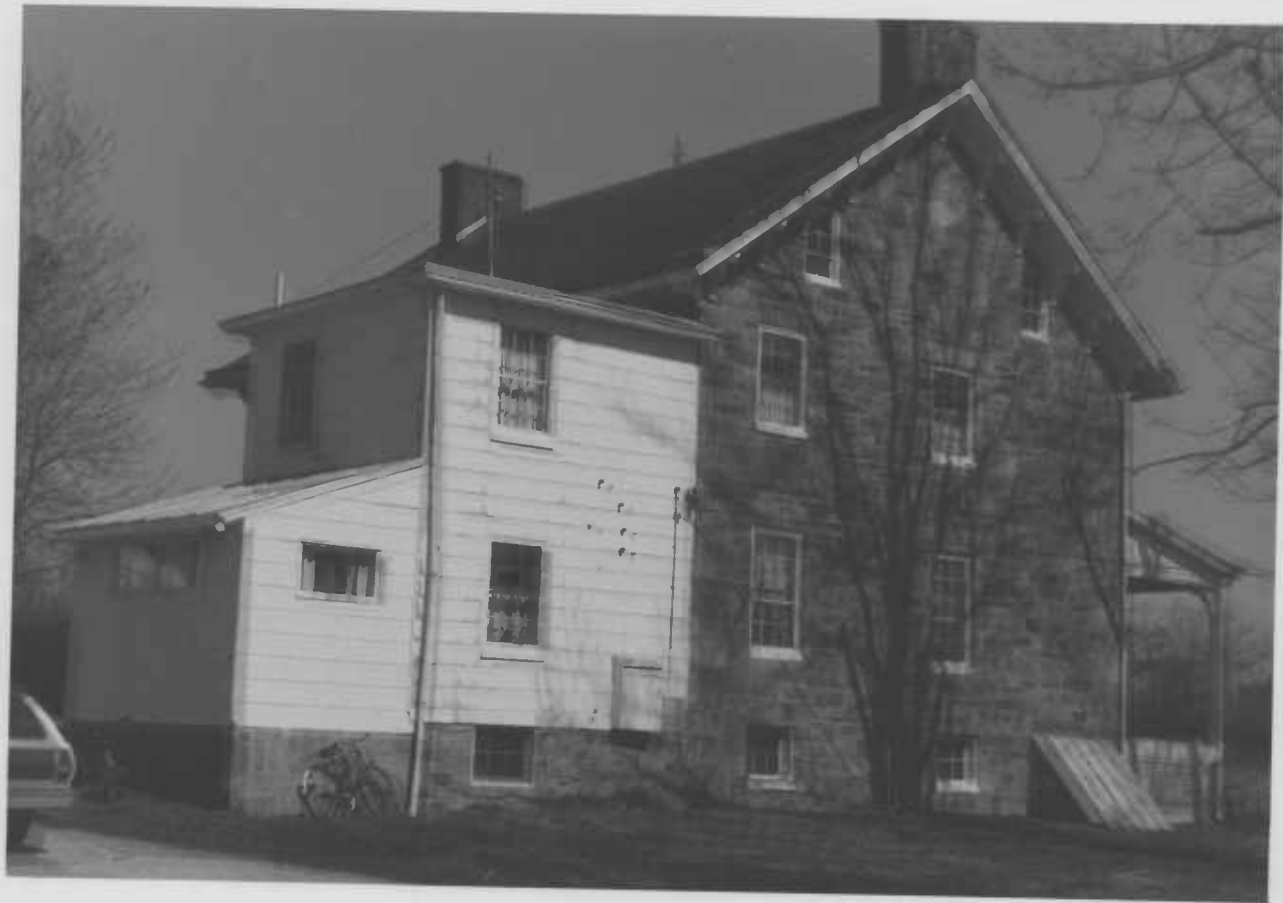
~~BRICK~~ WEST ELEVATION

The back of the house is partially covered by a two story frame kitchen wing which covers the southwestern two bays. A single story single bay shed roof addition covers the other first floor openings. As with most rear facades the fenestration is asymmetrical with a lower central second floor 6/6 sash that lights the stair well. Other details remain basically the same.

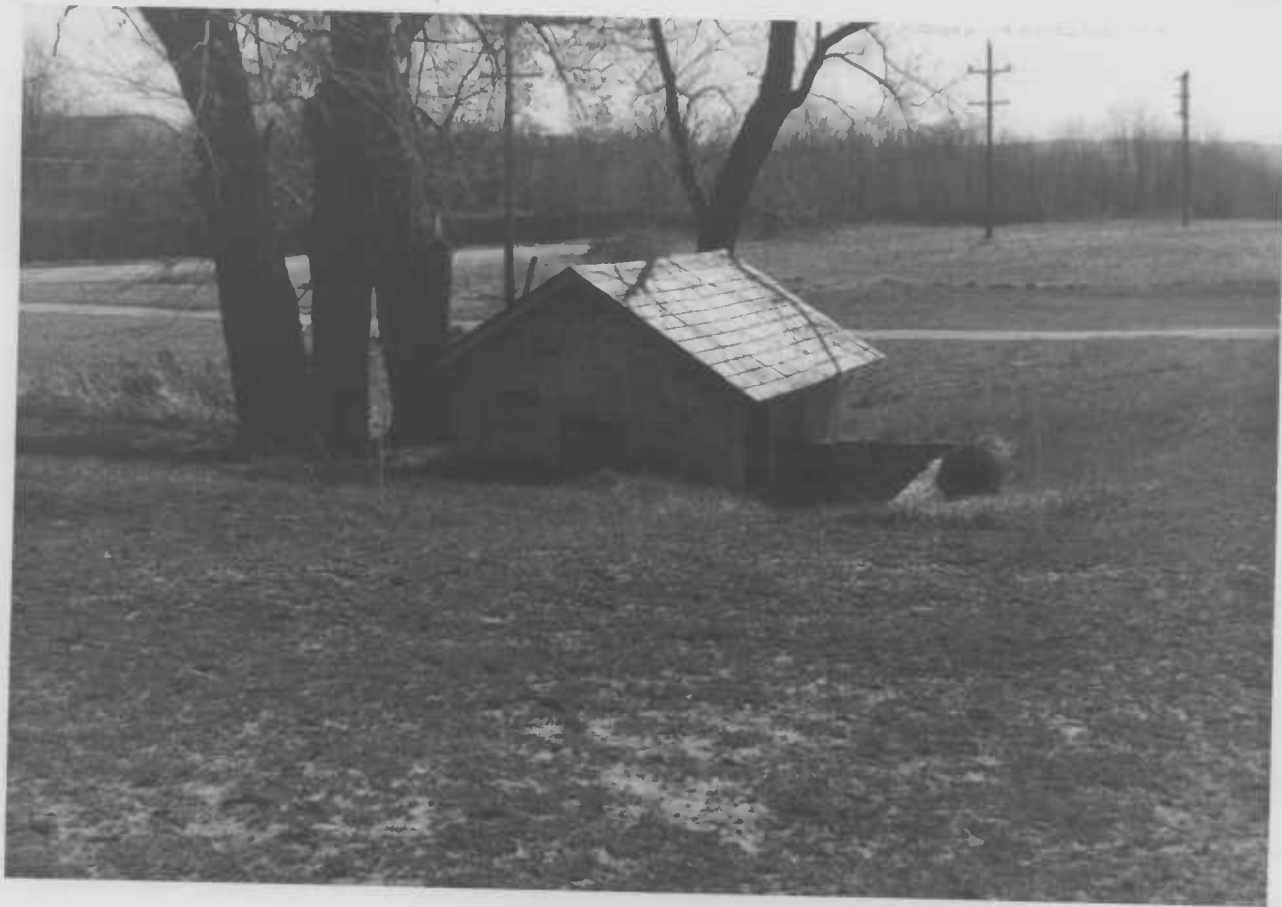
SPRINGHOUSE

The fieldstone foundation of a large barn remains south of the house and a fieldstone springhouse to the southwest of the house.
